June 28, 2019
File No. 262018.063

Subject: Department of Natural Resources Washington Geological Survey,
School Seismic Safety Assessment Project, Contract No. AE 410 -
Seismic Evaluation for **Fife School District**

School Buildings Evaluated in the Fife School District

1.1 Building Description

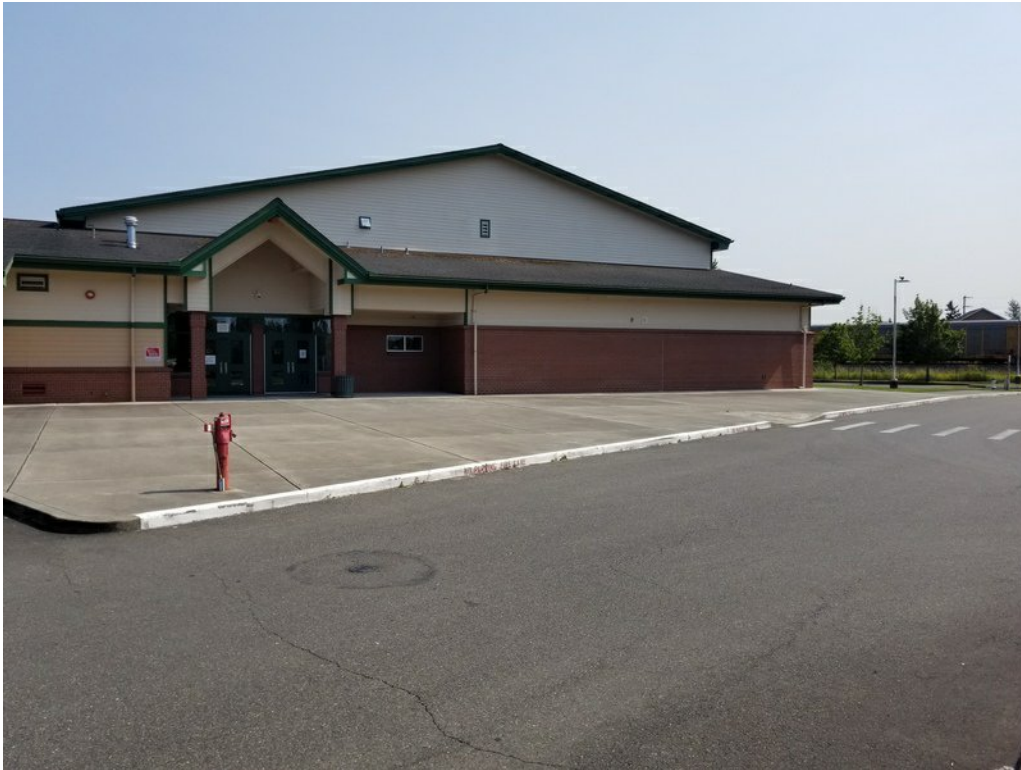
Figure 1-1. Building entrance exterior on the west side of the building .

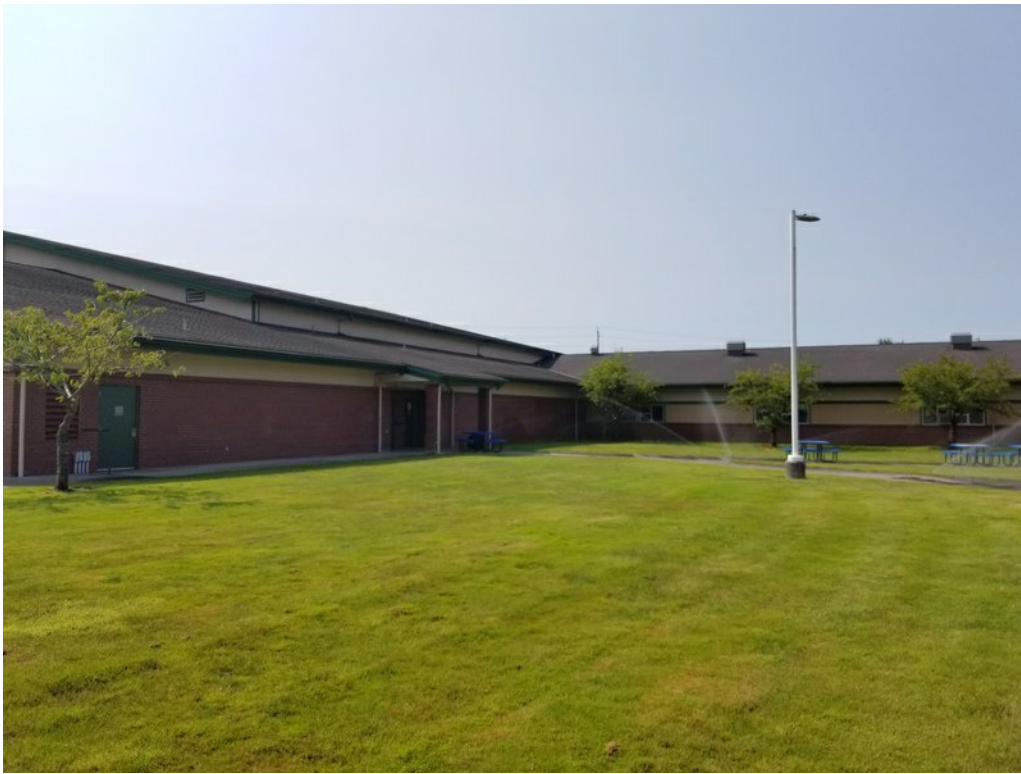
Figure 1-3. Exterior south side of building.

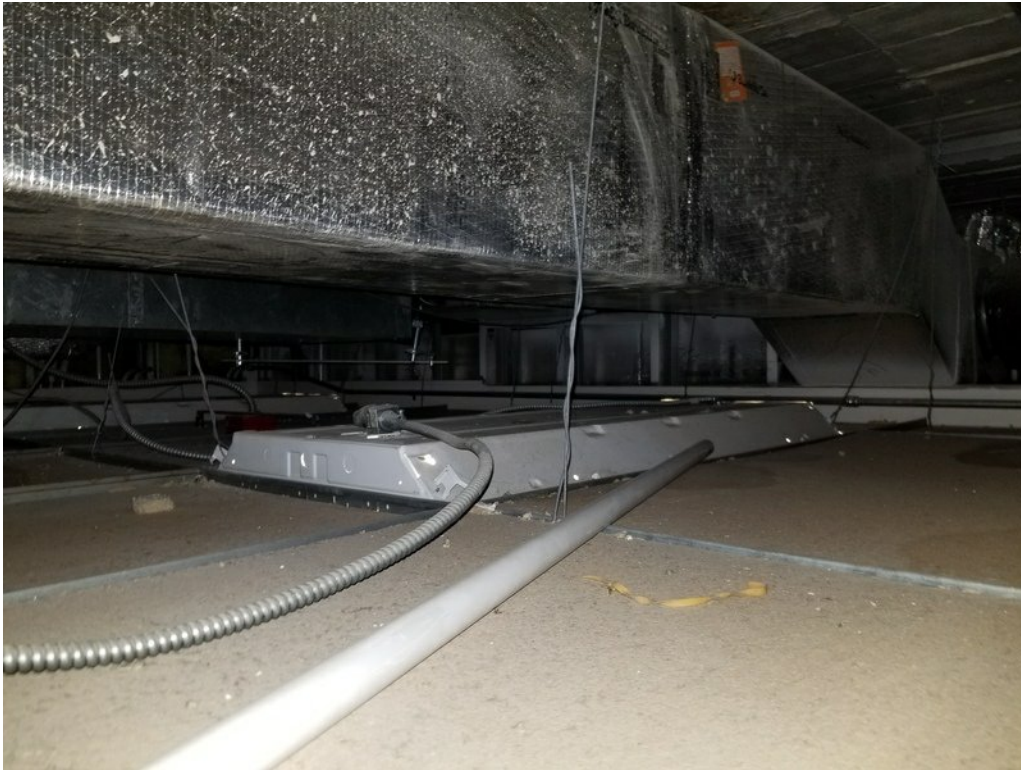
Figure 1-1. Building interior above ceiling tiles.

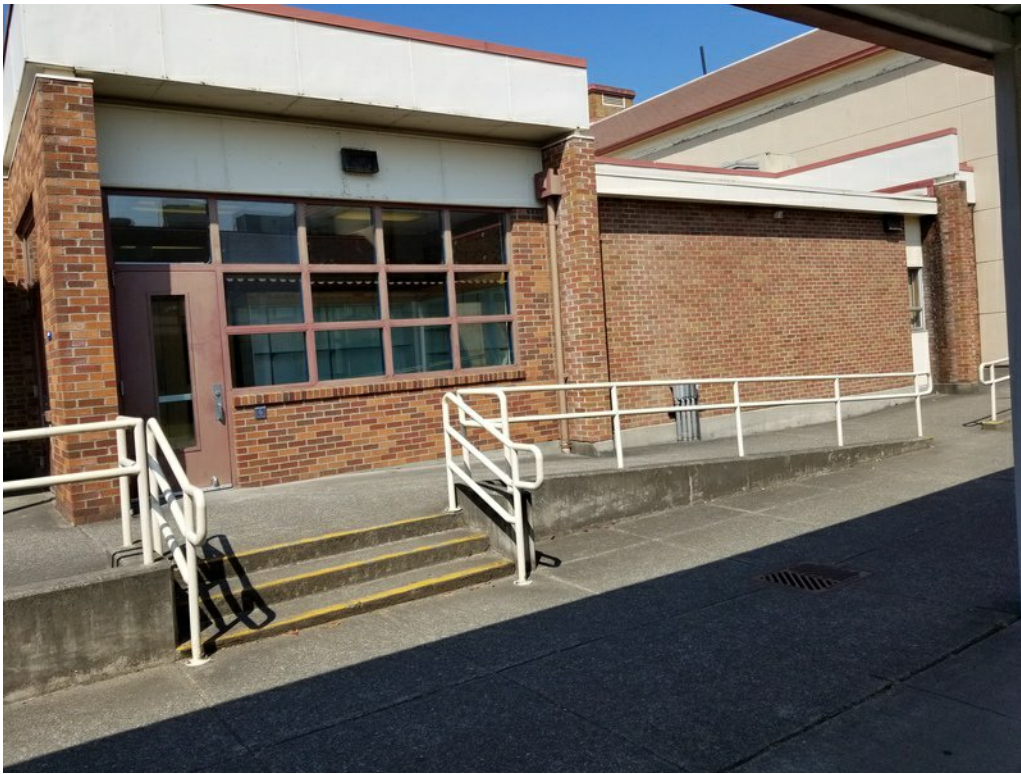
Figure 1-3. Exterior southeast corner of building.

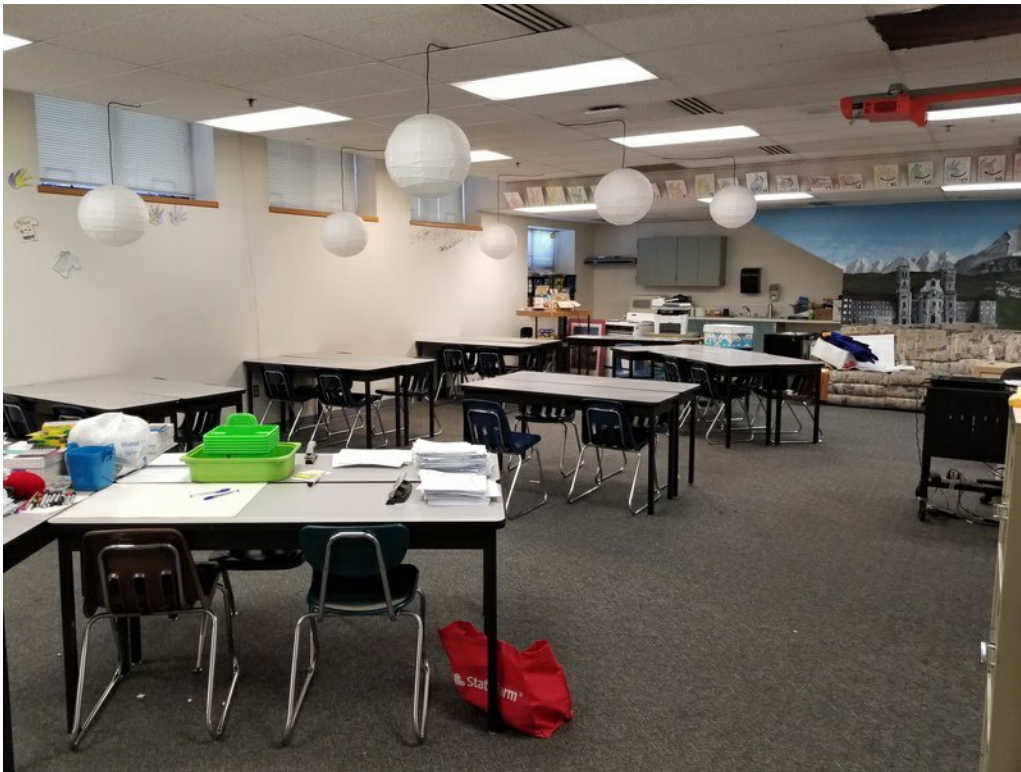
Figure 1-5. Classroom interior.

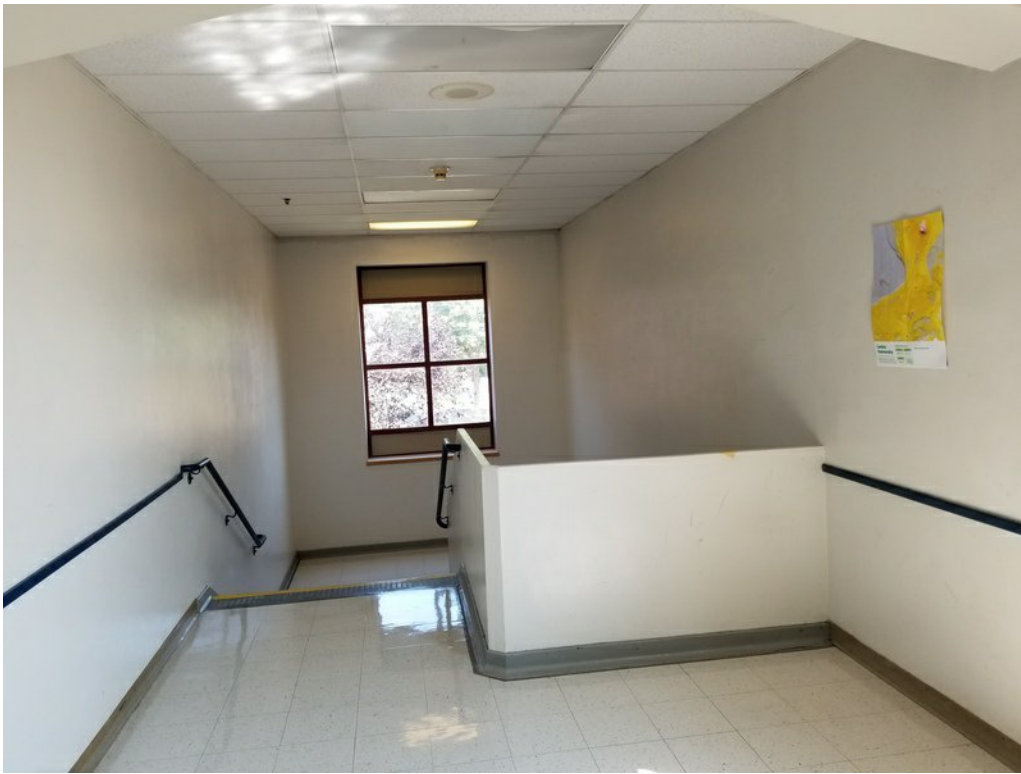
Figure 1-7. Stairwell interior.

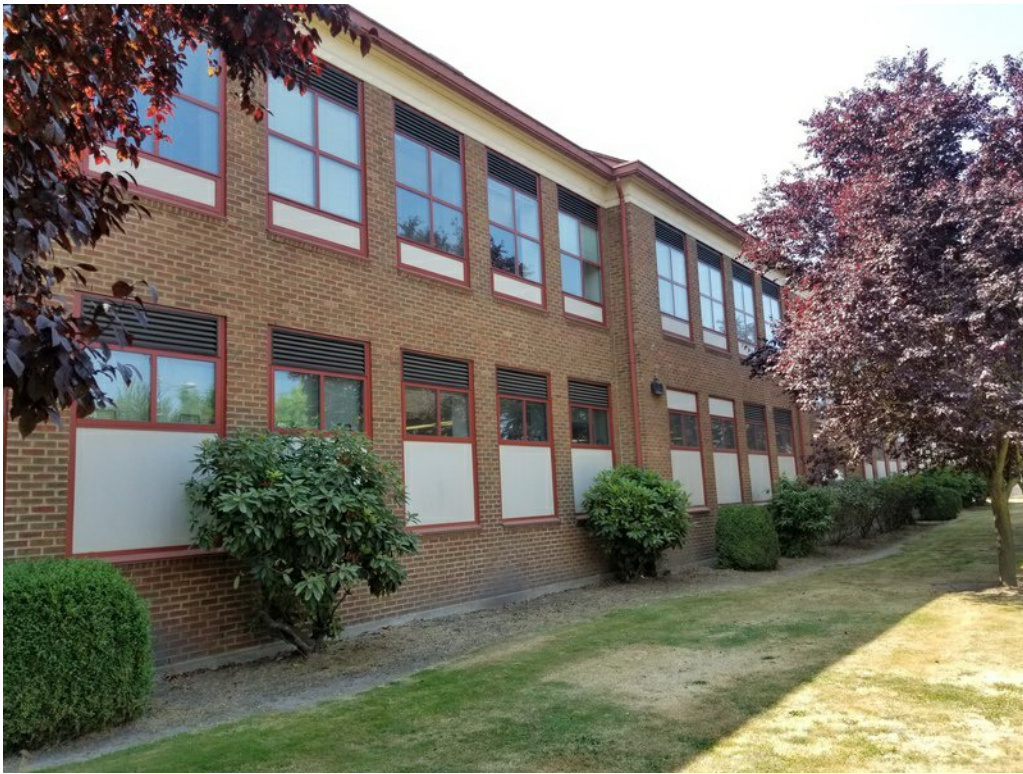
Figure 1-9. Exterior northeast corner of building.

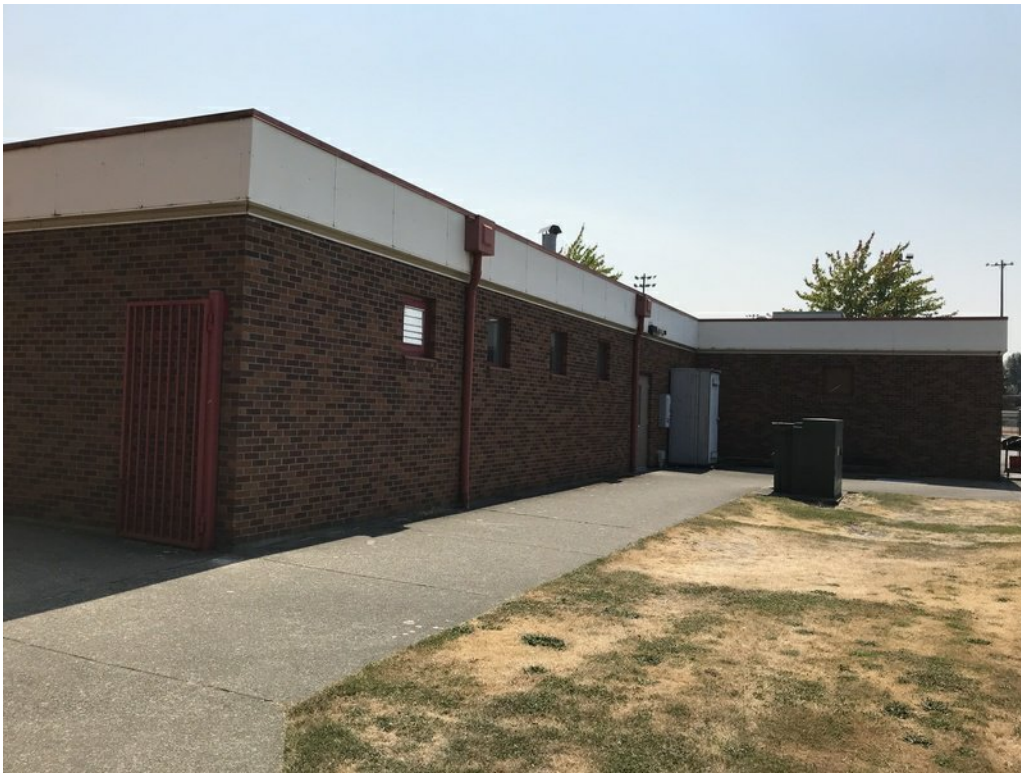
Figure 1-4. Northwest exterior of building.

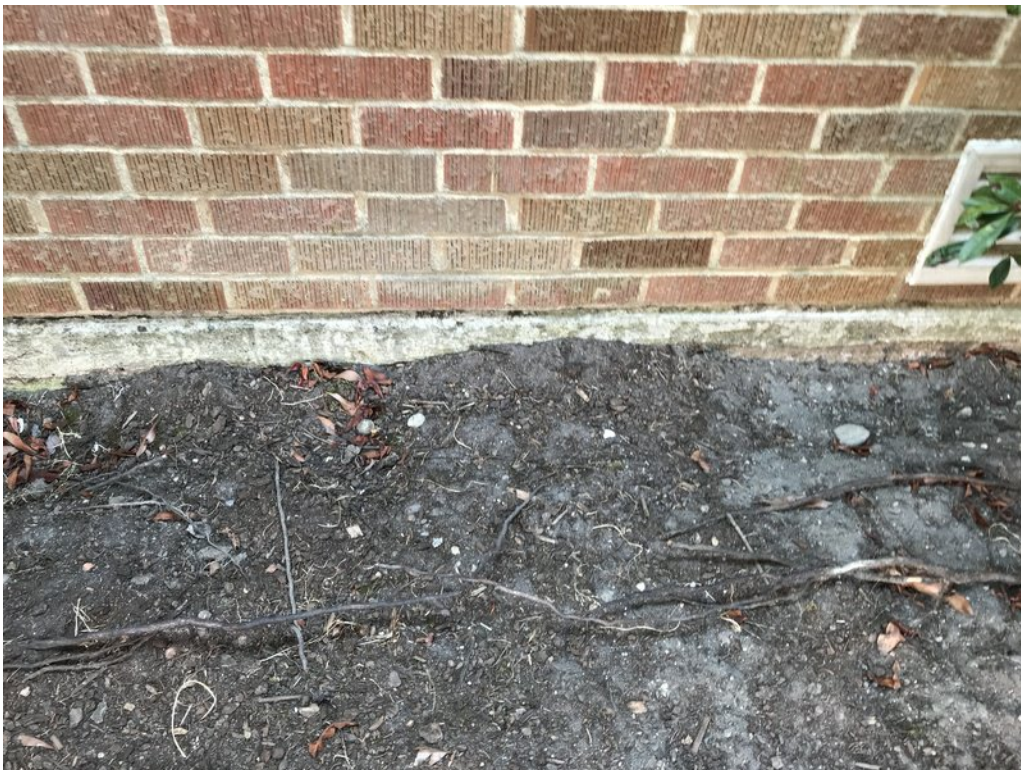
Figure 1-5. Foundation stem wall and brick veneer interface on north side of building.

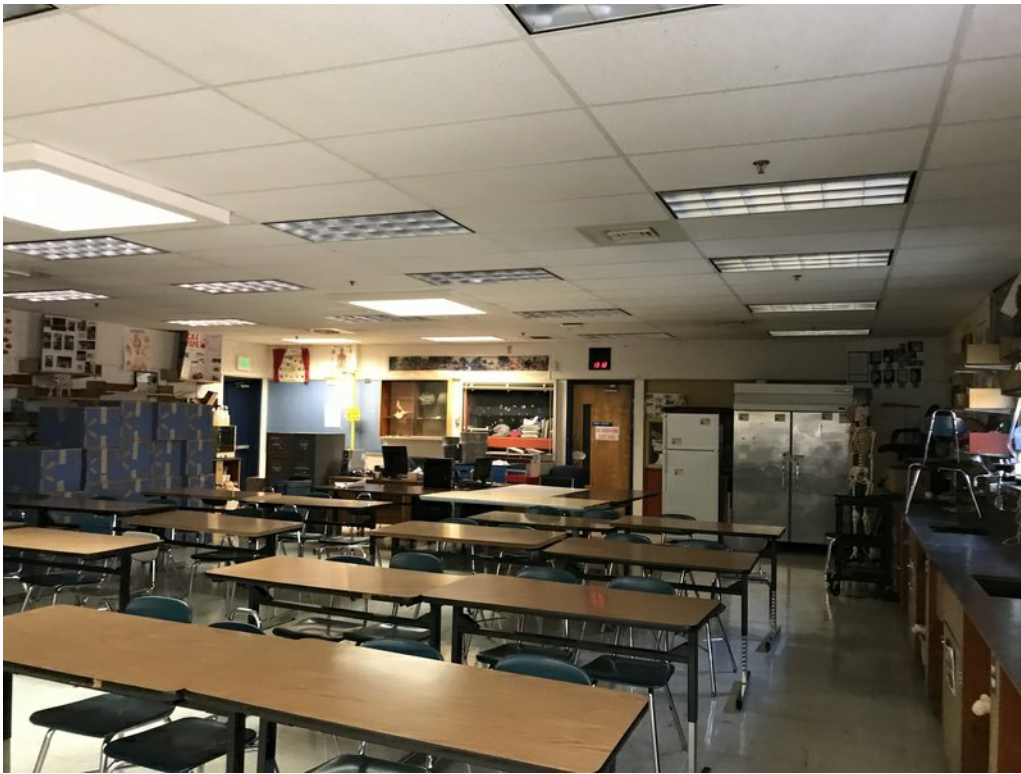
Figure 1-6. Classroom interior on east side of building.

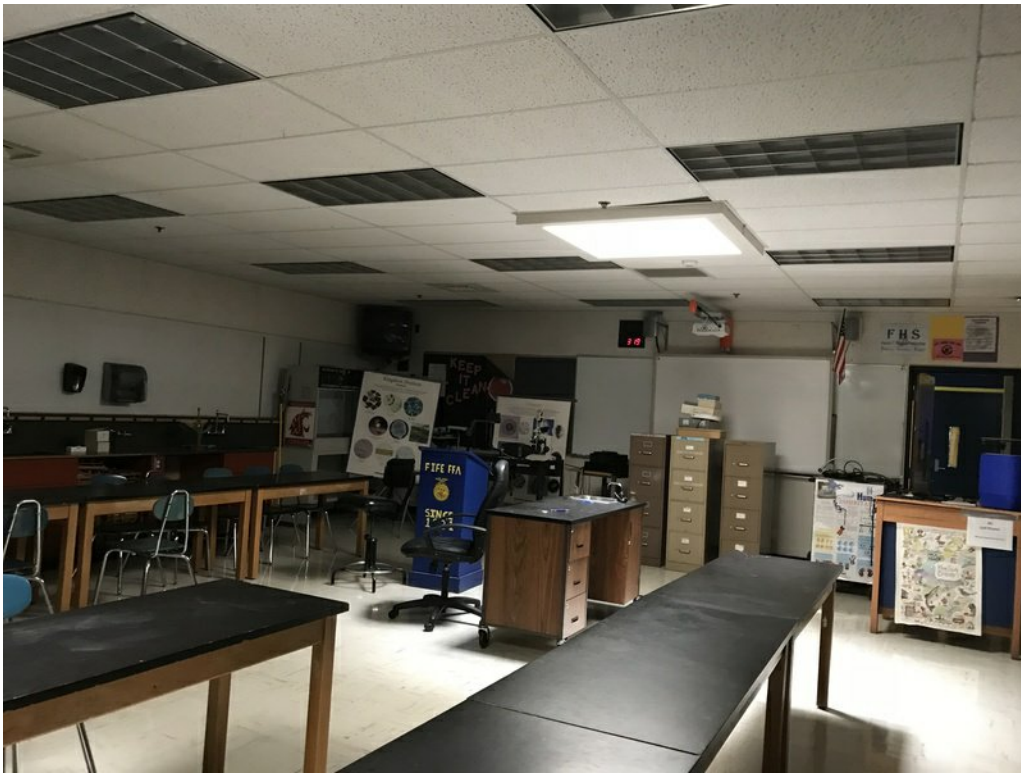
Figure 1-10. Central classroom interior photo.

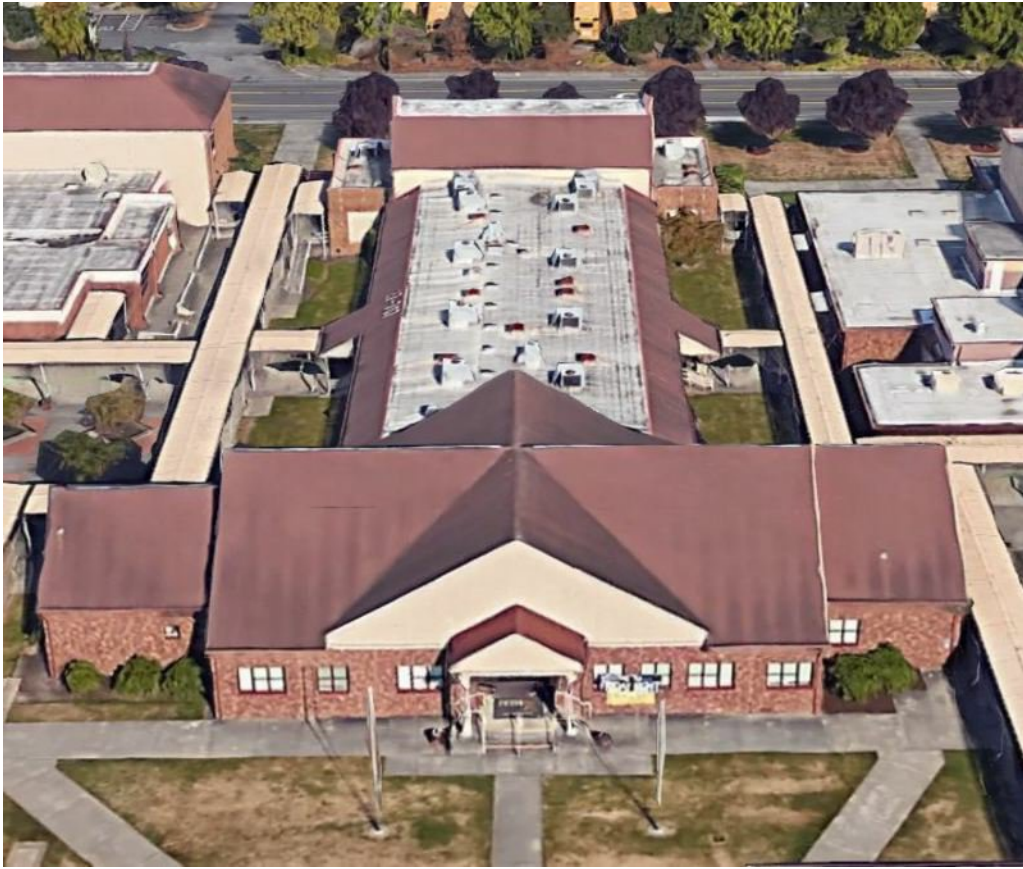
Figure 1-4. Aerial of Bldg 500 looking north

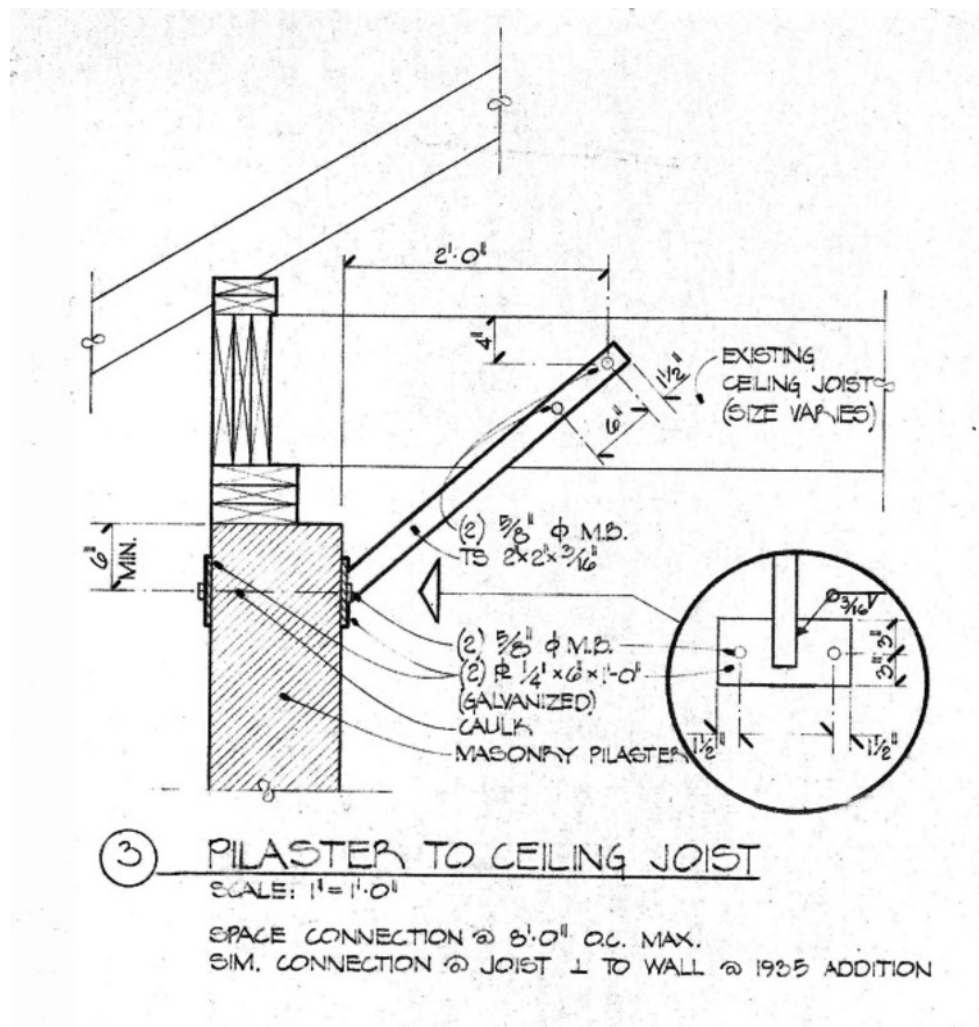
Figure 1-5. 1975 retrofit detail for anchoring of BMU wall

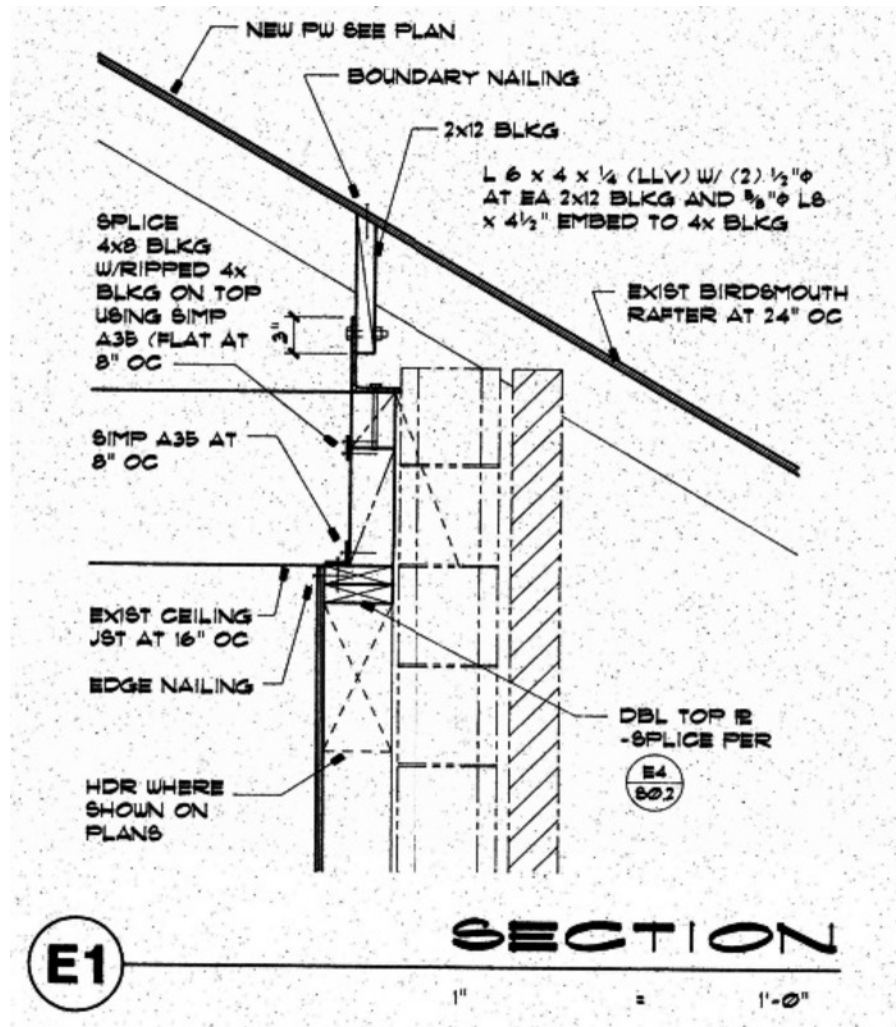
Figure 1-7. 1992 retrofit detail for load path from roof diaphragm to shear wall along perimeter brick bearing walls.

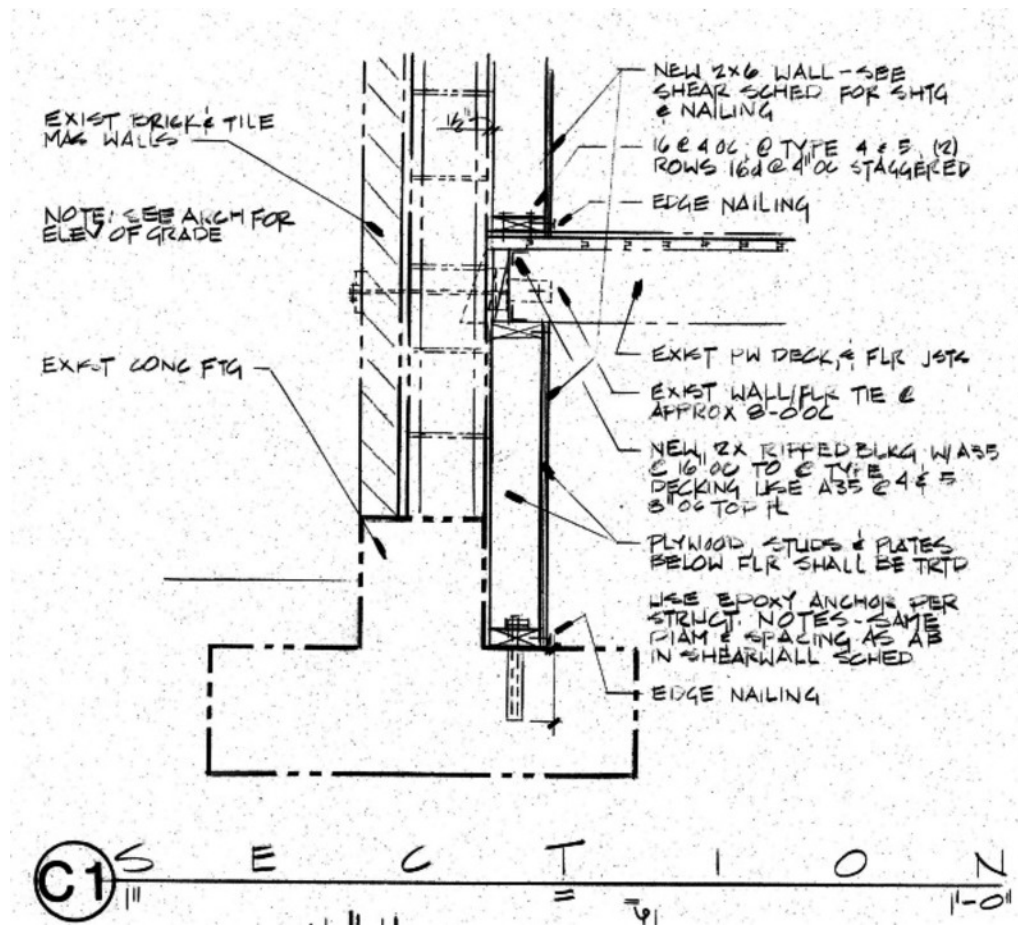
Figure 1-8. 1992 retrofit detail for load path from 1st floor shear wall to crawlspace shear wall to concrete foundation

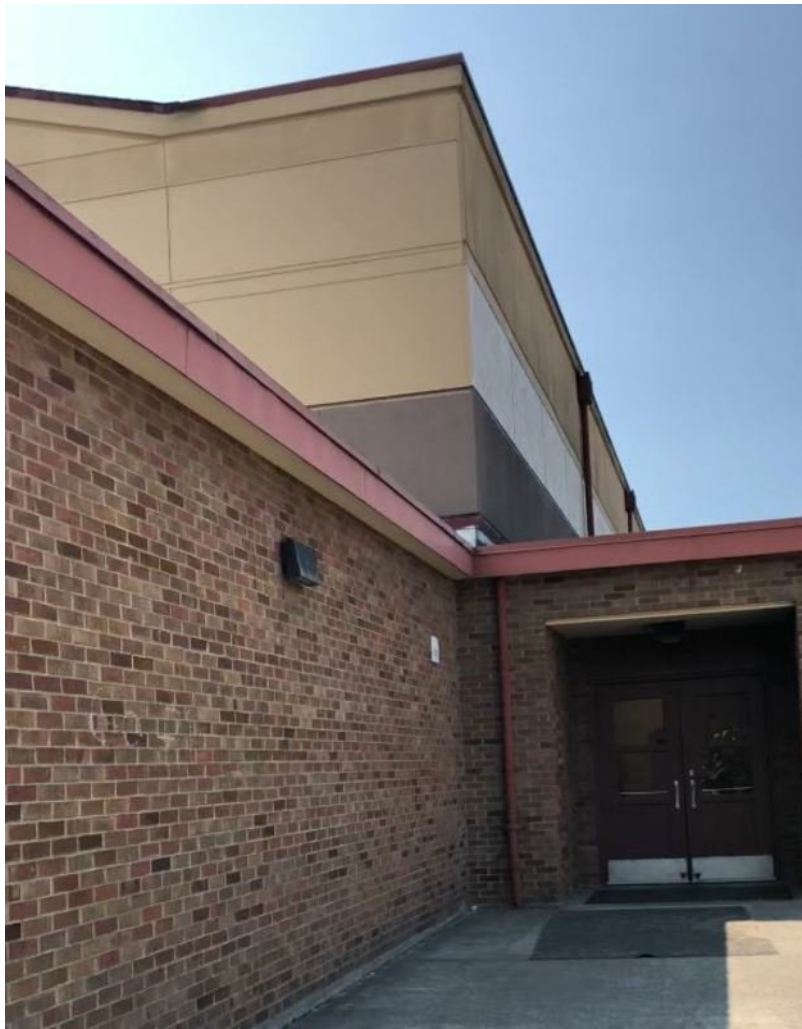
Figure 1-4. Northeast corner of Bldg 600

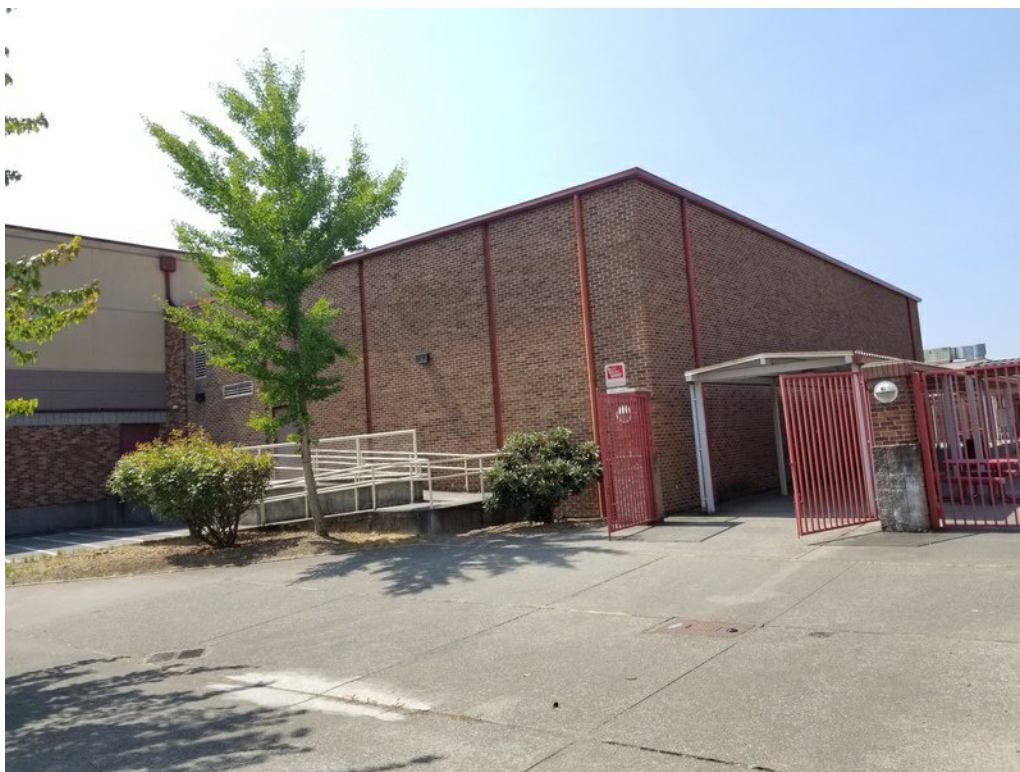
Figure 1-1. Exterior northeast side of building.

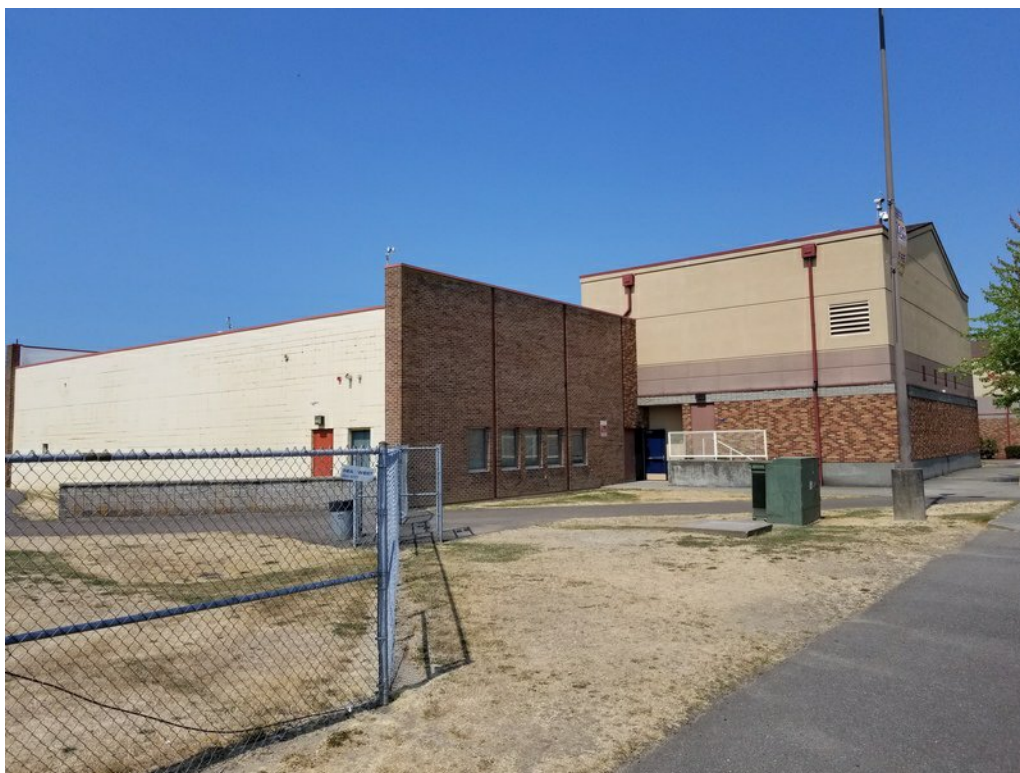
Figure 1-2. Exterior southeast side of building.

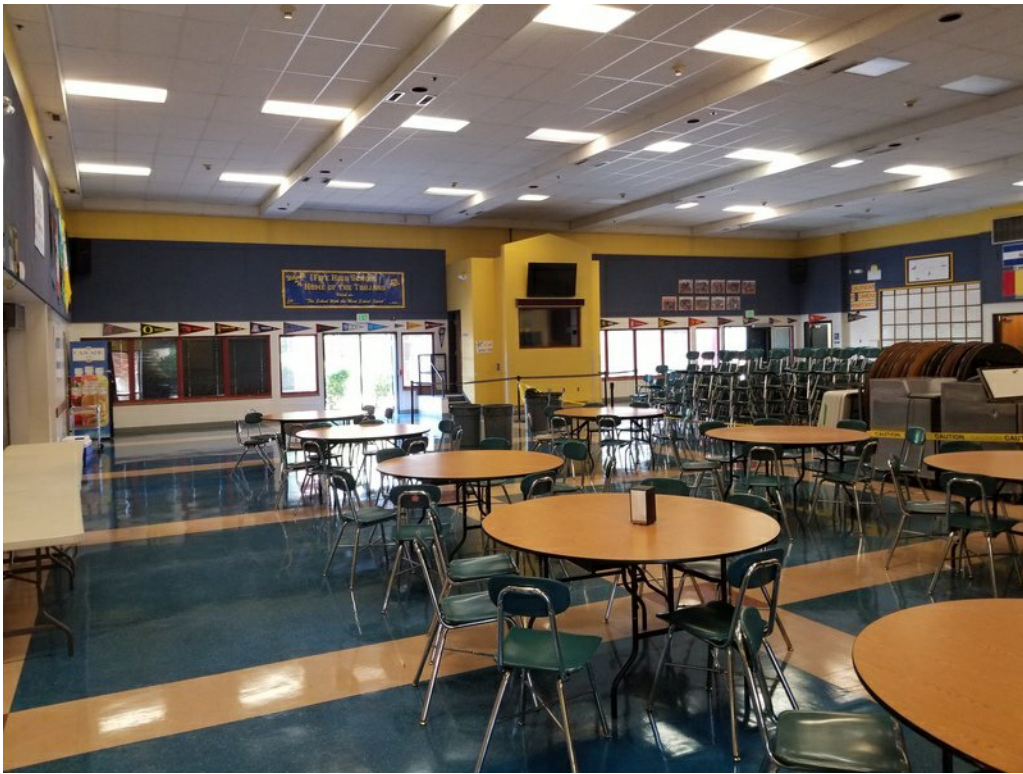
Figure 1-5. Cafeteria interior.

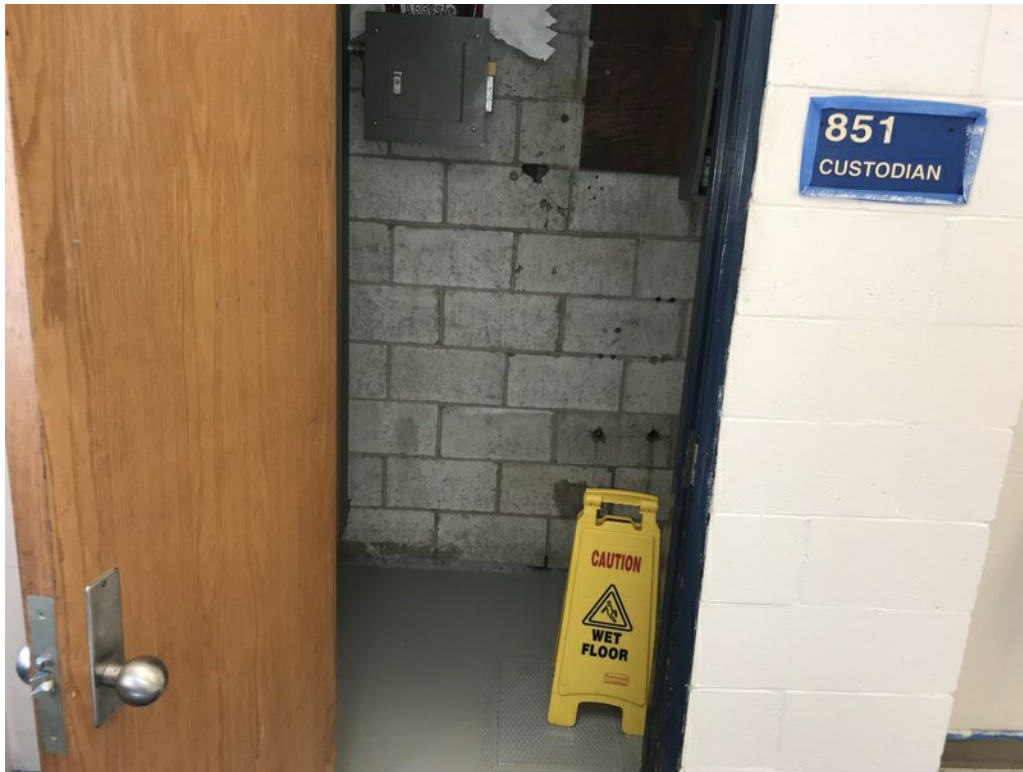
Figure 1-3. Bare CMU walls in custodial closet near building entrance.

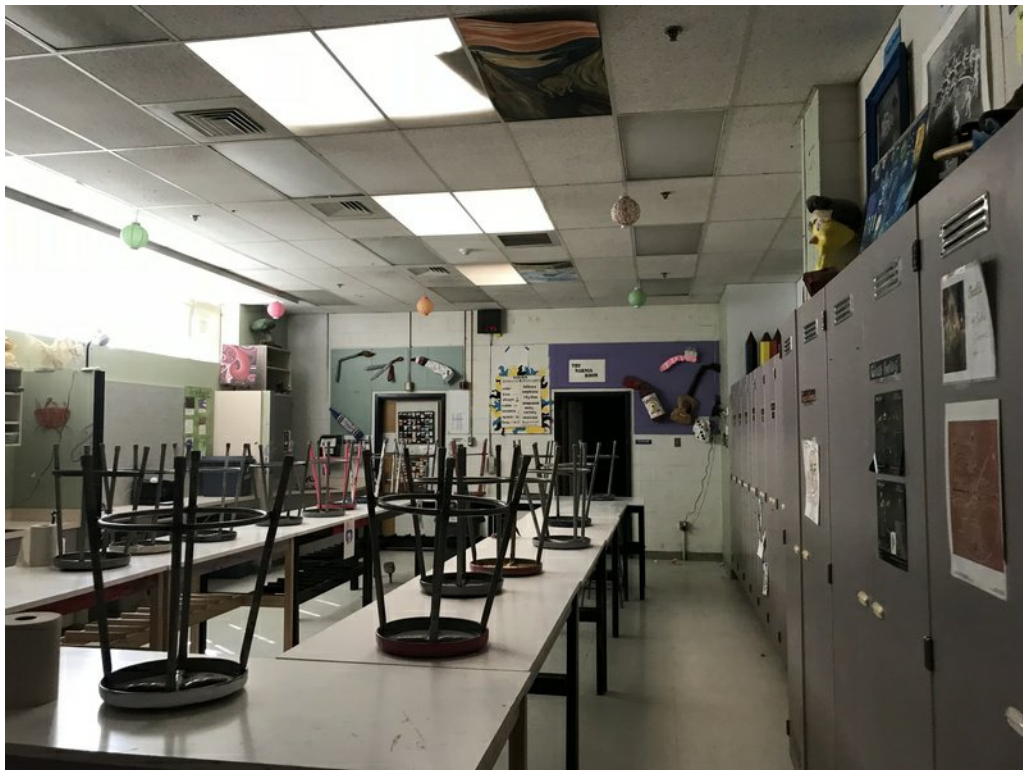
Figure 1-4. Art classroom with suspended ceilings, cabinets and desks.

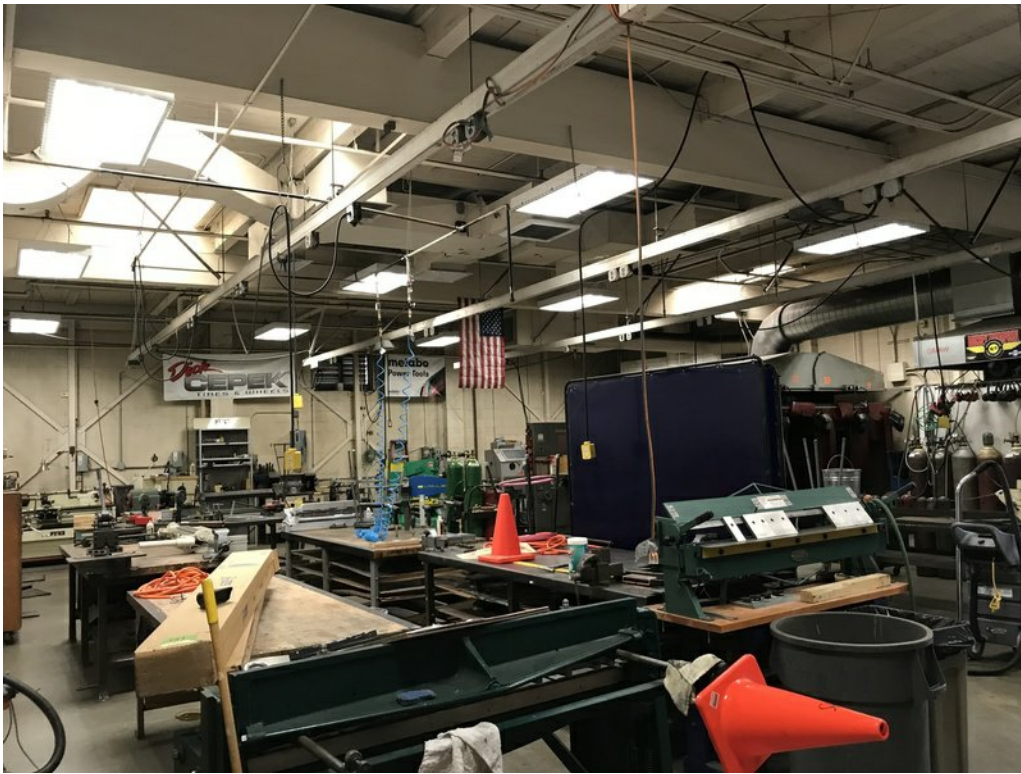
Figure 1-5. Shop Classroom 802.

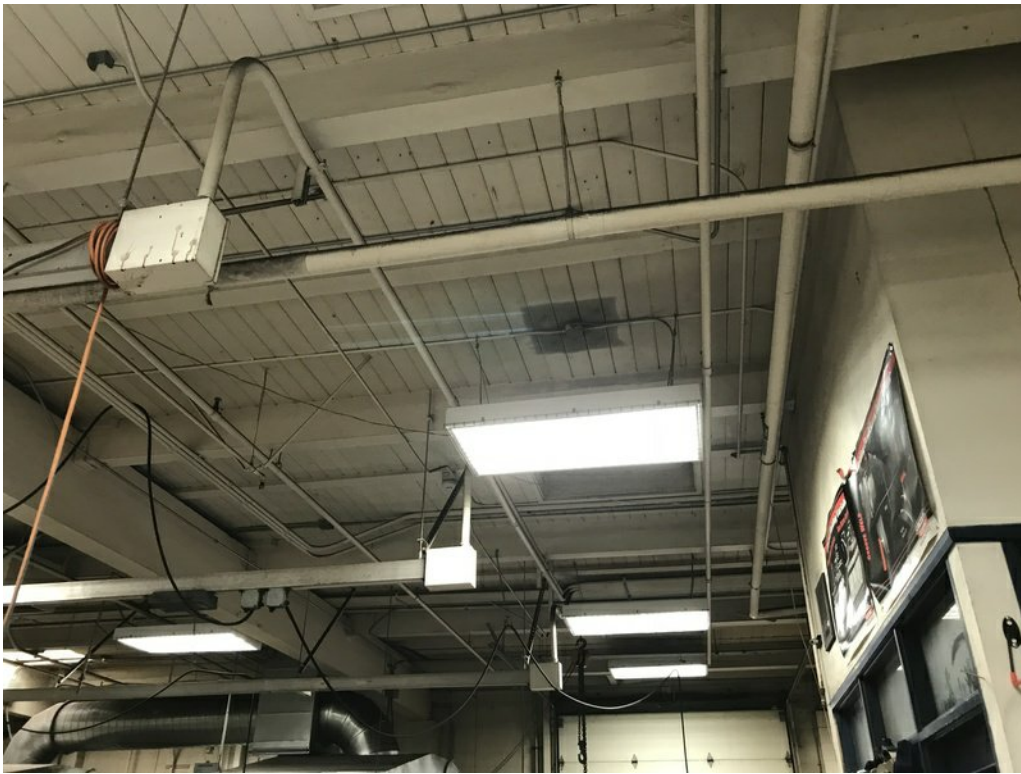
Figure 1-7. Classroom 802 underside of roof.

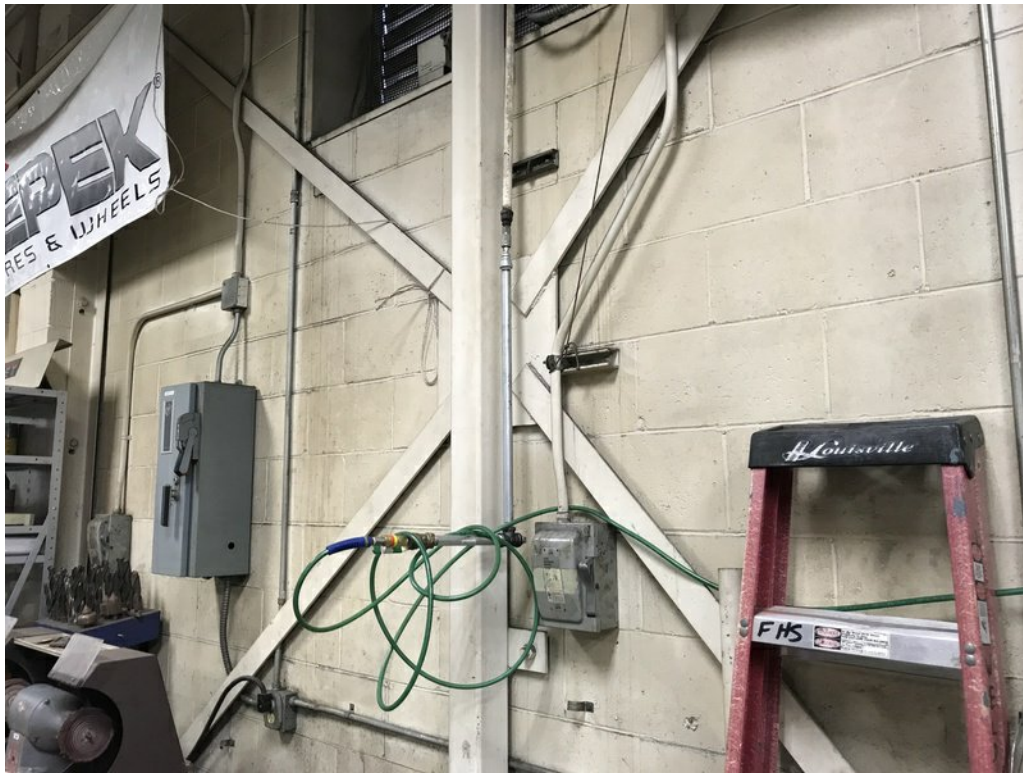
Figure 1-9. Flat strap bracing in Classroom 802.

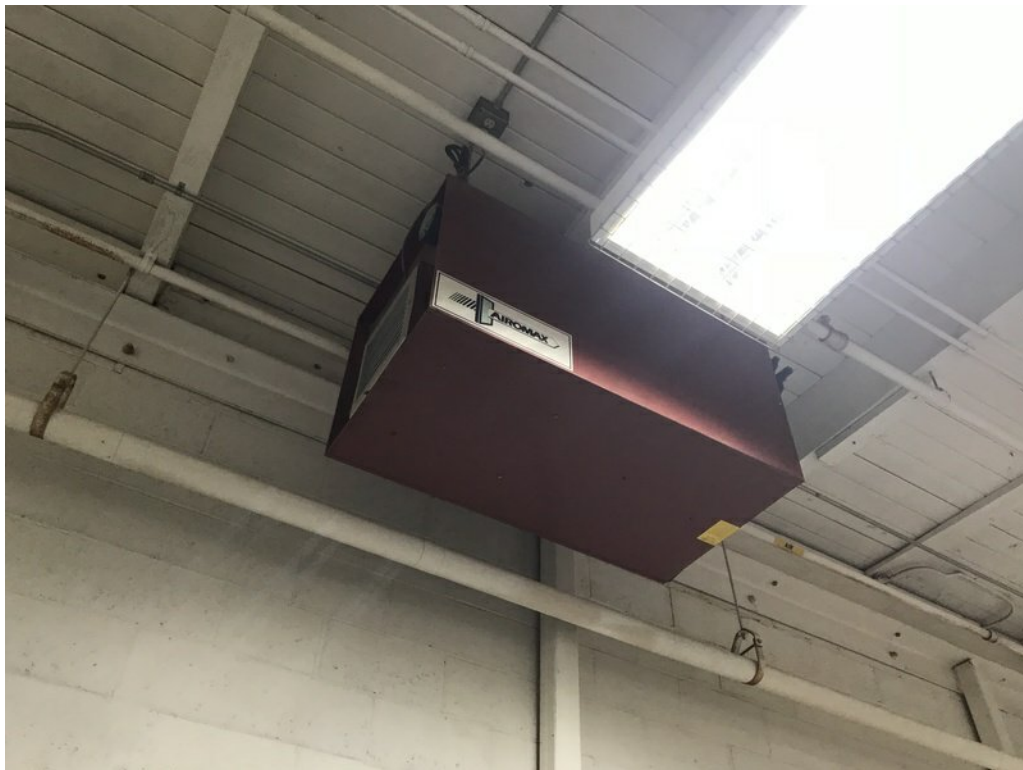
Figure 1-10. Mechanical equipment suspended from ceiling in Classroom 803.
